Case Report Zimmer Modular Revision Stem Failure on Total Hip Arthroplasty Due to Stem Fracture From Cone Taper Stem Junction

Citation Taheriazam A, Khanmohammadi B, Asadollah A, Dindar M. Zimmer Modular Revision Stem Failure on Total Hip Arthroplasty Due to Stem Fracture From Cone Taper Stem Junction. Journal of Research in Orthopedic Science. 2022; 9(1):57-64. http://dx.doi.org/10.32598/JROSJ.9.1.856.1

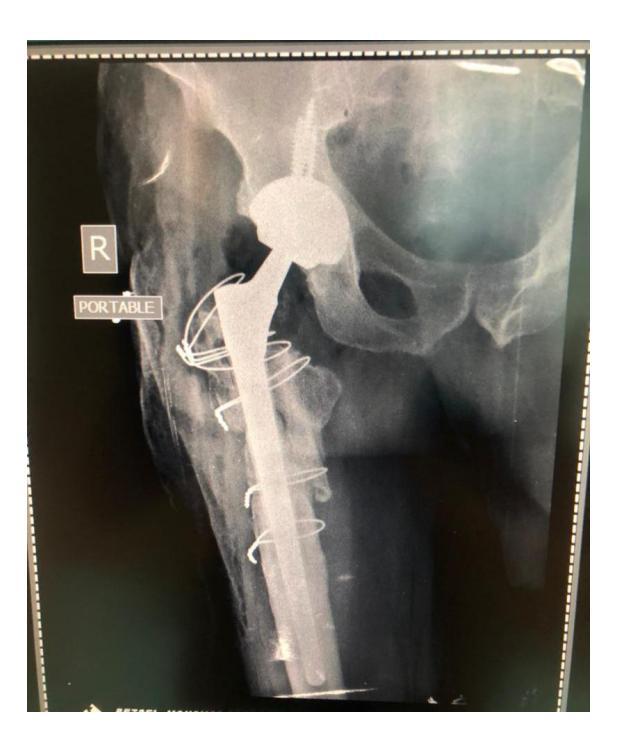
A 65-year-old and a 75-year-old man with severe obesity (body mass index >35) were referred to the hip and pelvic clinics because of pelvic pain after slow and light walking. Stem fracture from the stem junction was identified by X-ray imaging (Figures 1 and 2). It was noted that the Zimmer stem has failed catastrophically along the cone taper stem junction. They underwent hip arthroplasty revision with cemented tripolar cup and uncemented Wagner-SL stem. Using a Kocher-Langenbeck incision, revision of the total hip replacement, the conetaper was removed and the distal part was removed by femoral extended osteotomy. Nonmodular Wagner-SL (size 18-305 mm) was used after the ZMR removal and then the tripolar head and insert (52-head -3.5) were used (Figure 3). After extended osteotomy of the distal femur using a narrow osteotome, the previous stem was taken off from the bone. Reconstruction of the abductors and greater trochanteric fragment was done and all implant removal rules were considered. To choose the acceptable sort of device for the revision surgery, many factors should be considered. The femoral stem reconstruction plan depends on the amount of femoral bone loss; therefore, we should precisely determine the femoral bone loss. To restore the desirable leg length, we had to determine the exact leg length discrepancy during the preoperative planning. During revision surgery, it is essential to restore the limb length considering the changes which have occurred after the device failure. We should evaluate this discrepancy in an anteroposterior pelvic X-ray which provides sufficient information about the exact leg length size. Following the restoration of leg length discrepancy, the surgeon should pay attention to the abductor and adductor muscle tension which restoring their function is equal to a greater chance of successful revision and a lower rate of postoperative dislocations. The canal distal femur should be prepared to insert the femoral stem (Figures 4 and 5). The revision of general principles was observed. Sending culture during operation was negative for probable organisms, and the erythrocyte sedimentation rate and C-reactive protein markers were in a normal range. The count of polymorphonuclear was under 5-10 in each power field. Cefazoline prophylaxis 2 g/kg was given in addition to 1 g/kg during the operation. A total of 2 g/kg of tranexamic acid

Figure 1. Conventional radiography presenting zimmer modular revision stem failure in a 65-year-old man with sever obesity

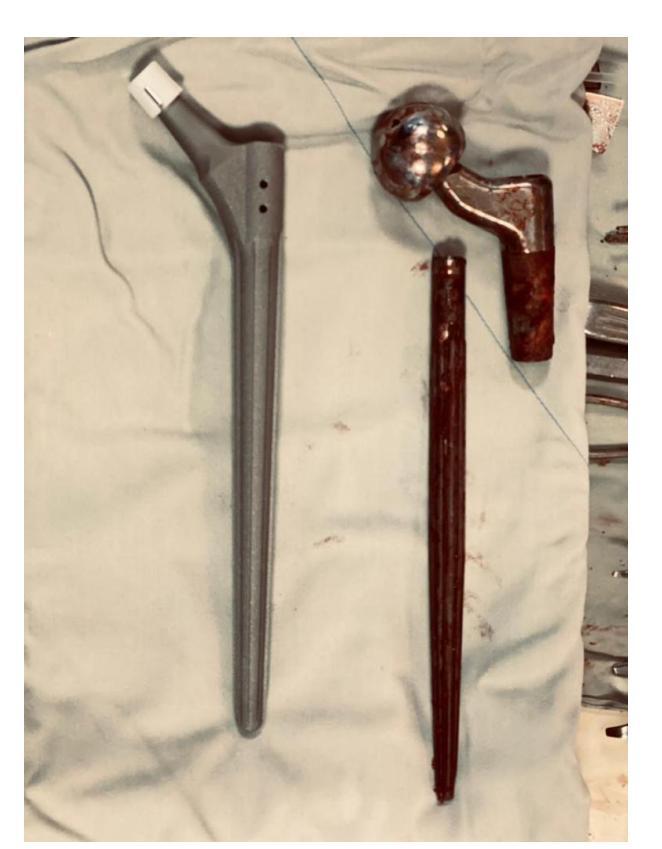
Figure 5. Comparison of new and failed implant
